Performance of Glass/Cladding of High-Rise Buildings in Hurricane Katrina

Ahsan Kareem and Rachel Bashor

NatHaz Modeling Laboratory
University of Notre Dame
Notre Dame, IN 46656

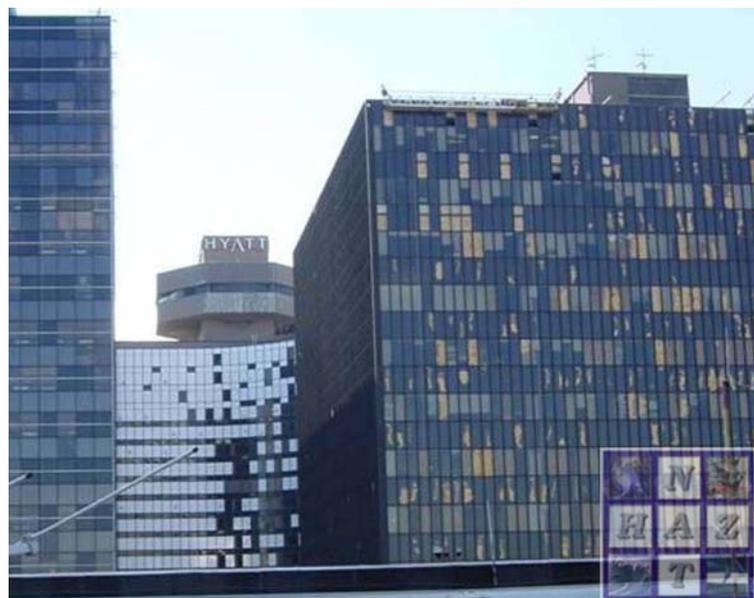
Figure 2 Damage to Hyatt Regency Hotel and Amoco Building as seen from the roof of City Hall

The Amoco Building sustained a large amount of glass and cladding damage as well as damage to the rooftop penthouse (See Figures 2 and 5). A large percentage of the windows were broken and boarded up with plywood. Of the windows that were not covered, many of them showed pitting where a missile had impacted the window. The roof of the Amoco Building originally had a layer of loose pea gravel several inches thick that covered the built-up roof surface completely.

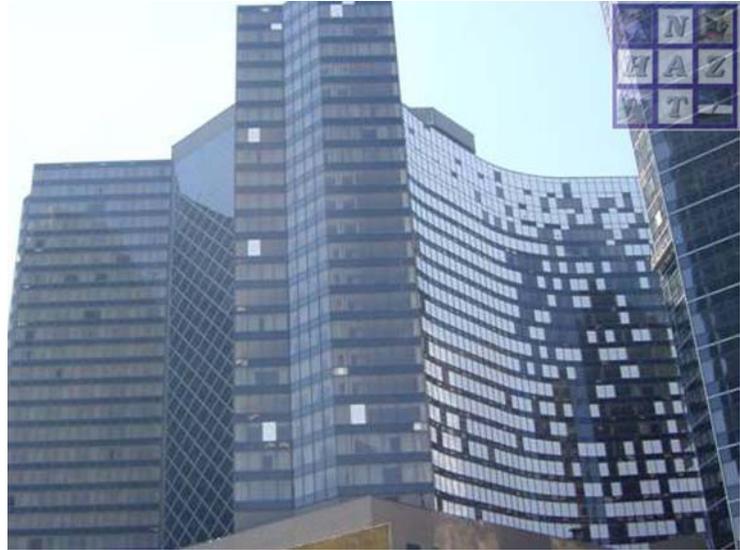
The Hyatt Regency Hotel, located near the Superdome, suffered significant glass and cladding damage, especially on the north face of the hotel (See Figure 3). Nearly every window on the north face of the hotel was broken as it experienced not only high winds during the storm, but also wind with debris accelerating through the canyon formed by the upwind buildings. Some of the falling glass during its downwards trajectory damaged glass at lower levels, initiating a domino effect causing more damage to windows below. Along with the glass damage, the building roof was also significantly damaged. Large portions of the roofing material were torn up and missing. There was evidence of abrasions on certain faces of the various roof structures, including the round center tower, and evidence of façade elements ripped off at several corners. The debris found on the property included gravel, fasteners, and large pieces of glass likely from upwind buildings. In addition, the inside of the hotel was heavily damaged with walls torn down and room contents scattered everywhere (See Figure 4).

Figure 3 East and north faces of Hyatt Regency Hotel.

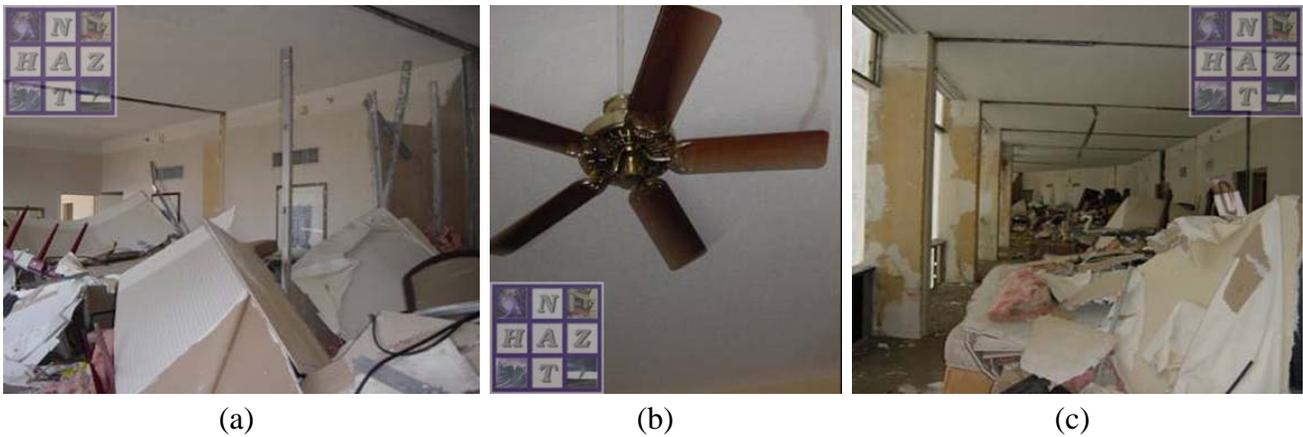
Figure 4 Inside view of the top, north floor of the Hyatt Hotel: (a) East, (b) Ceiling fan pushed

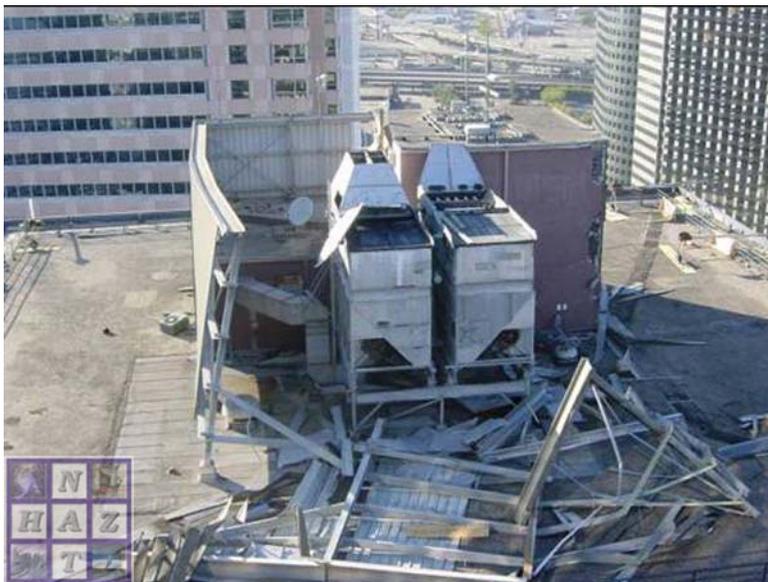
The wind blew off much of the gravel, piling some up along the south parapet and exposing sections of tar. The penthouse structures on the roof suffered considerable damage, as their large beams had been blown off supports and their connections torn out of the cinder block wall. The four columns that supported the penthouse had all been pushed away from the supports - one was missing from the rooftop. It appeared that the bolts that held the steel columns to the concrete bases had been sheared off. Most of the penthouse cladding had been blown off; some large components were found on an adjoining low-rise building south of the Amoco Building.

Figure 5 Rooftop penthouse on Amoco Building was nearly destroyed

Another cause of damage can be contributed to poor connections and lack of redundancy. This applies mostly to roof top structures. Nearly all of the damaged penthouses had missing siding at the corners associated with high levels of suction. For example, the round tower on the roof of the Hyatt was missing siding on the corners of the north face. Also, miscellaneous fasteners were found on the roof of the Hyatt among the debris. Another example of inadequate connections and bracings was the penthouse on the Amoco Building.

Commonly, in extreme wind events, an overall lack of wind resistant provisions is responsible for most structural damage, including glass and cladding, rather than simply the severity of the storm. This conclusion was previously noted during Hurricane Celia in Corpus Christi, Texas, Hurricane Alicia in Houston, Texas, Hurricane Andrew in South Florida, and Typhoon York in Hong Kong. Cladding damage as experienced during Hurricane Katrina is not only costly but also threatens lives, exposes building interiors to costly damage, and puts buildings out of service for extended periods of time thus seriously impacting the community's day-to-day infrastructure and economy. As long as the availability of wind-borne debris exists in urban areas, it will continue to threaten the integrity of fragile building envelopes even in storms that experience winds under design level. Current levels of cladding damage and associated losses are unacceptable. In order to alleviate this situation, effort must be made to limit the roof top gravel, secure appurtenances and appendages, and ensure the integrity of penthouses and railings.

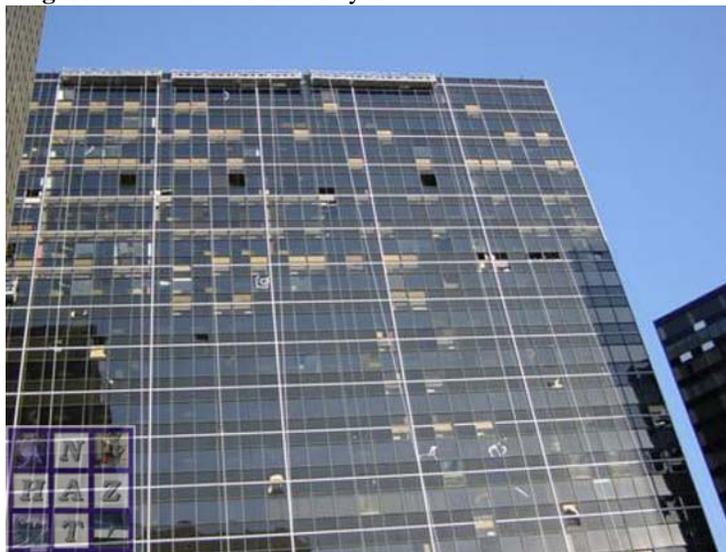
The building known as 1250 Poydras also suffered damage to the glass and cladding, especially on the north face (See Figure 6). The old gravel roof of this building had been replaced two years ago; however, the roofing membrane had bubbled up in the northeast corner. Additionally, a roof drain had been pulled up. The penthouse was in good condition with exception of the loss of one large door. Overall the roof of 1250 Poydras performed satisfactorily. However, some debris from different sources was found.

Figure 6 West face of 1250 Poydras.

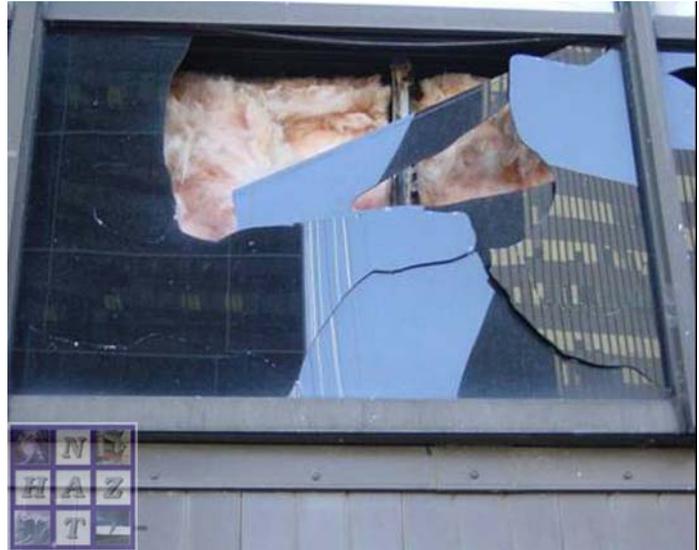
The gathered evidence suggests that the majority of the damage was likely caused by wind-borne debris. The wind-borne debris included pea gravel, rooftop appurtenances, siding, and penthouse structures which became airborne and caused significant damage to the glass and cladding of the surrounding buildings. The finding of gravel, glass shards, pitted glass and other debris on or inside buildings supports this scenario. The breakage patterns to the spandrel glass supports the missile impact theory due to the appearance of impact-induced pitting with cracks that spread from the impact point (See Figure 7 and 8). Given the orientation of the buildings in relation to the damaged areas and the availability of wind-borne debris from upwind buildings, it is

Figure 7 Broken window on north face of Hyatt Regency Hotel, likely caused by missile impact.

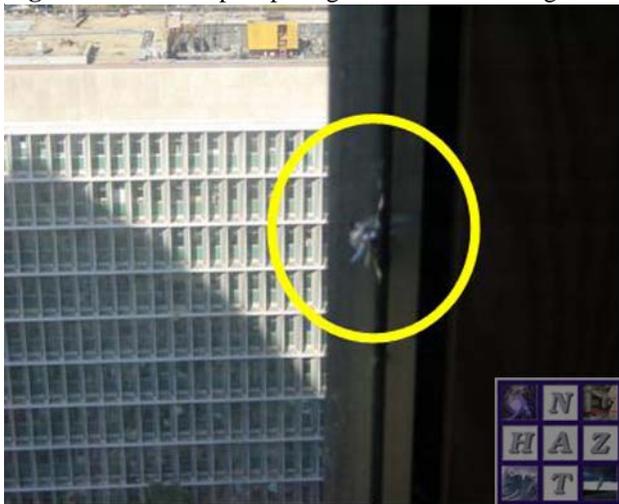
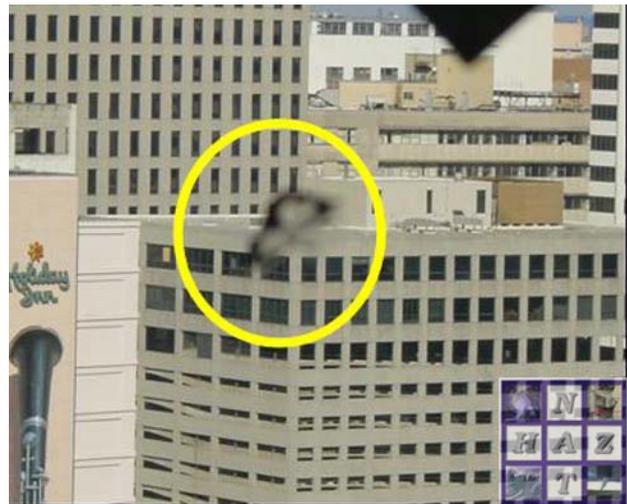
Figure 8 Missile impact pitting on Amoco Building.
