Investigation Report

October 27, 2010

Aerial Lift Accident

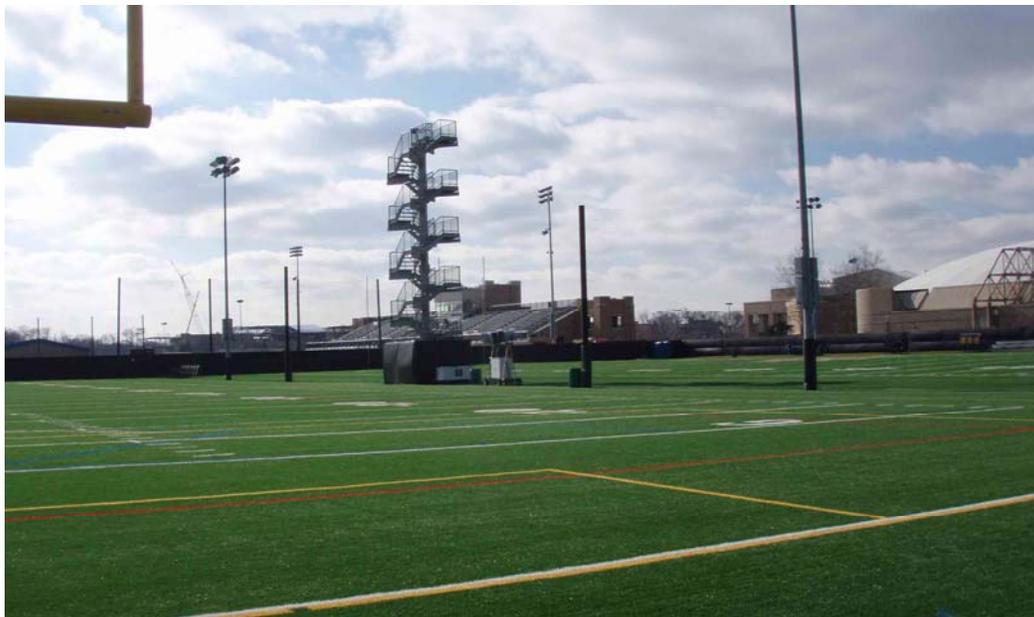
Figure 4. Photograph looking upwind from the accident site (Southwest) to the direction from which the wind gust occurred that tipped over the Marklift.

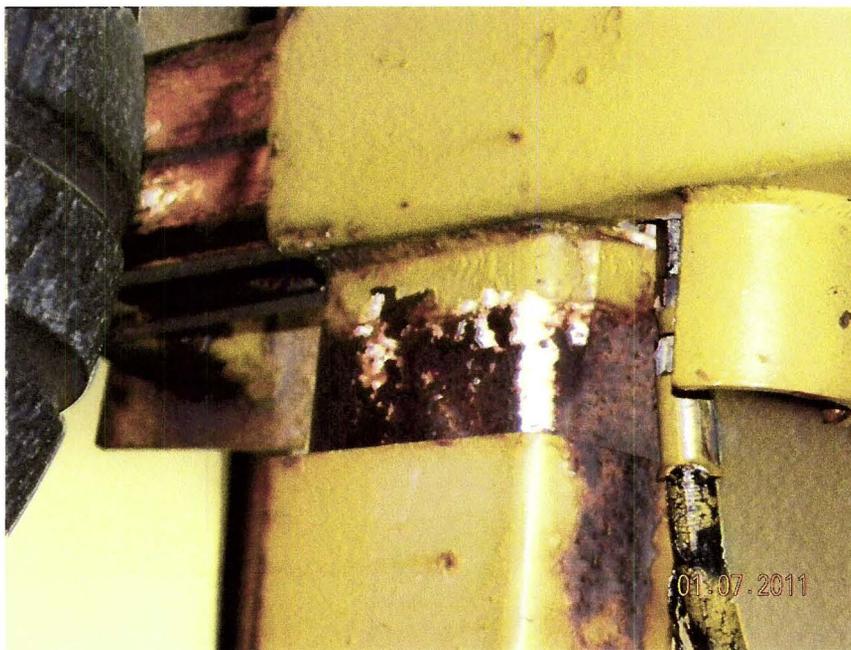
Photo 5 - Outrigger Beam Showing Extension – Painted and Unpainted (Corroded)

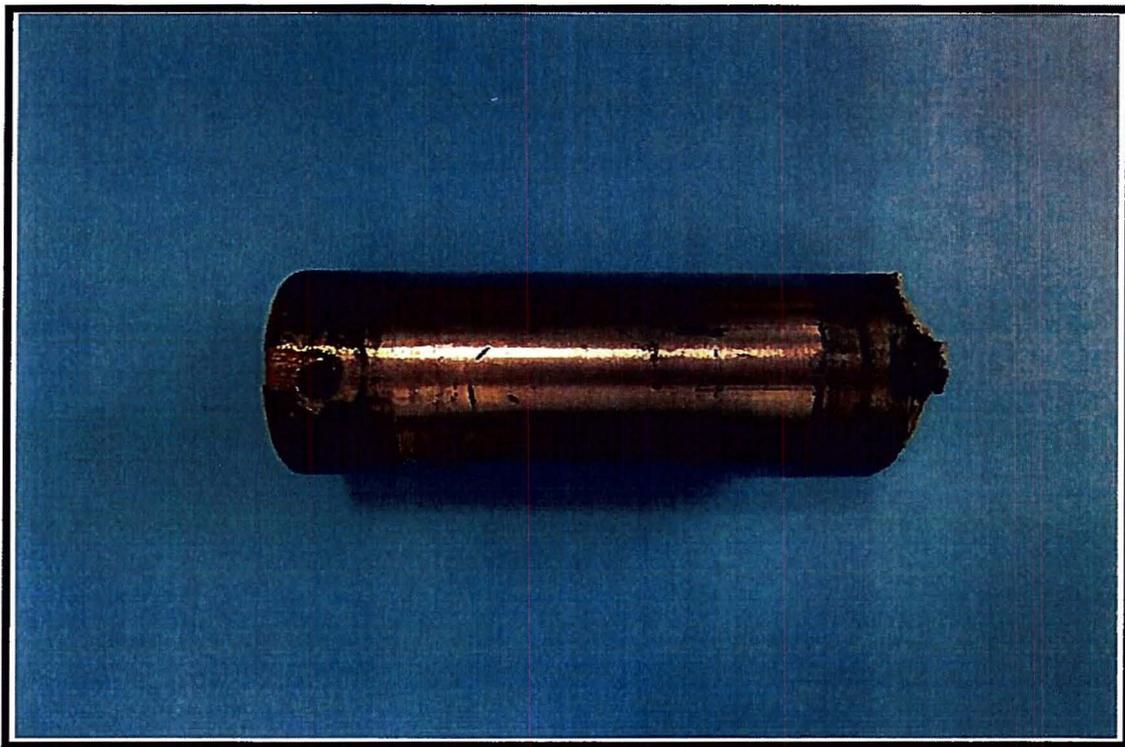
FIGURE 1: Overview of pin.

The steel pin provided to SEA is approximately 2" in diameter and 5 1/2" long (**Figure 1**). One end appears to be saw cut and is stamped with the number 8 (**Figure 2**). There is a depression drilled near this end and scrape marks or gouges lead from the depression to the end of the pin (left side of Figure 1). This depression appears to have been a receptacle for a retention screw, and the scrape marks are consistent with the pin being forced from the joint despite the presence of the retention screw.
