Investigation Report

October 27, 2010

Aerial Lift Accident

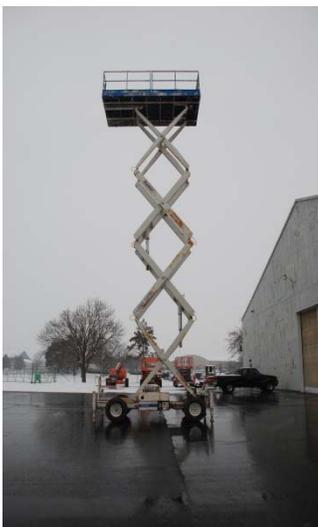
Marklift MT40G

All three scissor lifts could be extended to heights of 40 feet, with the SkyJack and JLG lifts capable of further extension. The Marklift and SkyJack lifts have “outriggers,” metal leg-type devices, on all four corners that lower before the lift is extended to increase stability. The JLG lift does not have outriggers, but instead is stabilized by a significantly heavier base than the other two vehicles. When the lifts are fully extended, according to multiple operators, even slight breezes or walking on the platform may cause the lifts to sway back and forth. Industry experts report that such minor swaying is not itself dangerous and is part of the design attributes of the lifts.

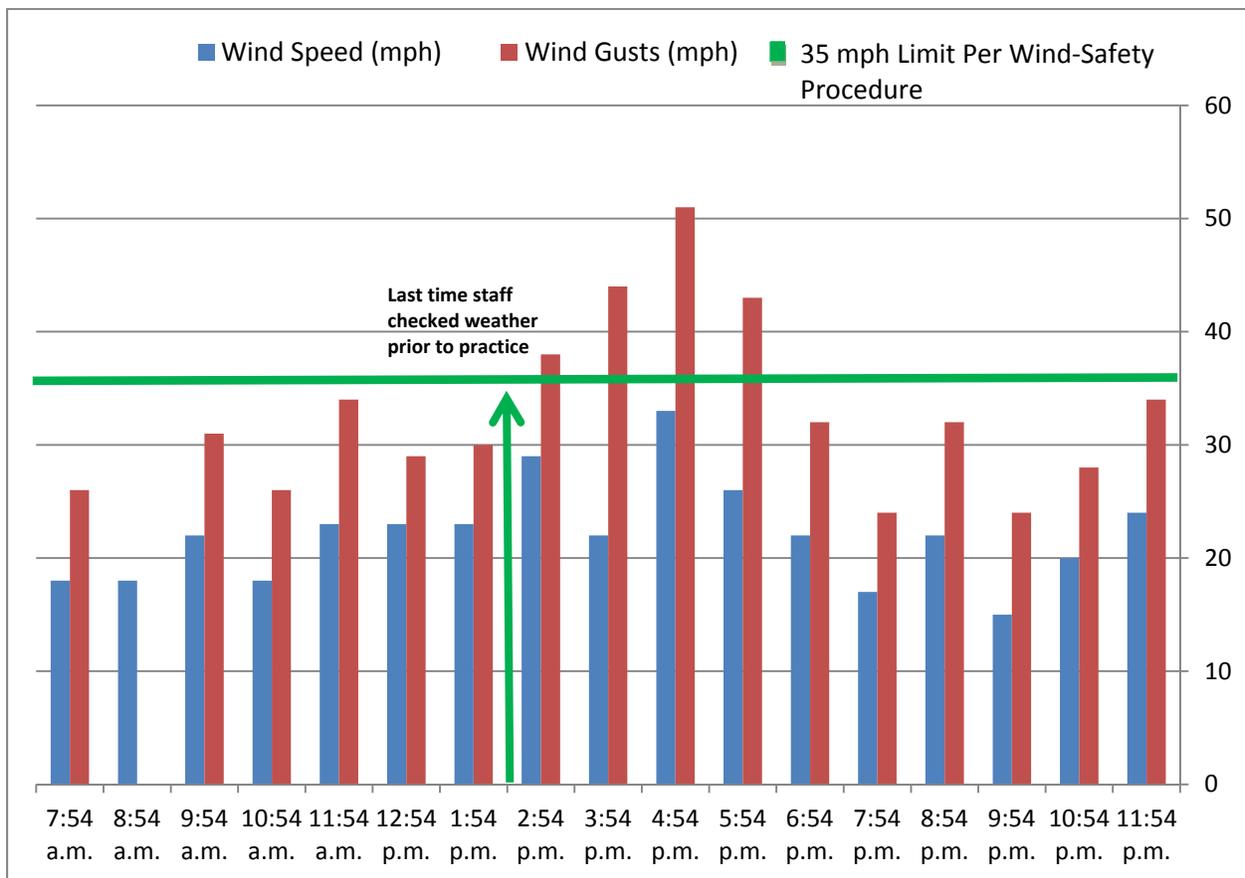
WIND SPEEDS REPORTED AT SOUTH BEND REGIONAL AIRPORT BY NATIONAL OCEANIC AND ATMOSPHERIC ADMINISTRATION: WEDNESDAY, OCTOBER 27, 2010⁴

As illustrated by the bar graph below, wind speeds increased significantly from the time the staff last checked the weather and went outside for football practice to the time of the accident.

When staff members checked the weather prior to practice, they saw reports of 23 mph sustained winds with 30 mph gusts. But wind speeds increased during practice, punctuated by

⁴ Due to the lag in reporting time, the charts depicting NWS wind data do not illustrate real-time gusts. For example, the 51 mph gust at 4:54 p.m. in this chart does not reflect the gust that caused the accident. Rather, the 51 mph gust depicted above occurred between 4:44 and 4:54 p.m. at the South Bend Regional Airport. Experts determined that the gust that caused the accident, which was 53 mph, occurred at the airport at 4:29 p.m. and, on the field, at approximately 4:55 p.m.

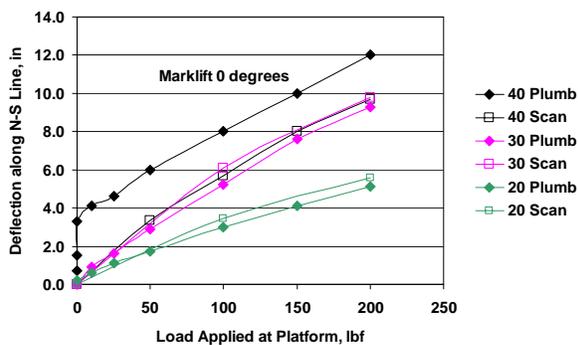
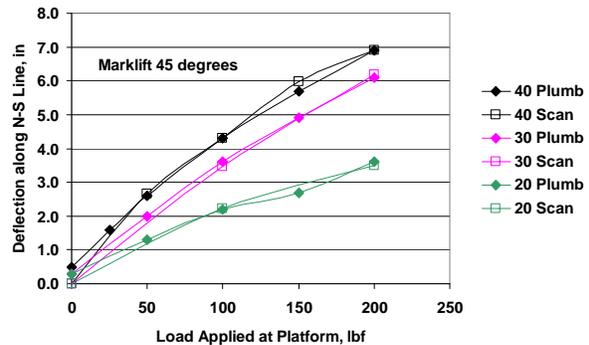
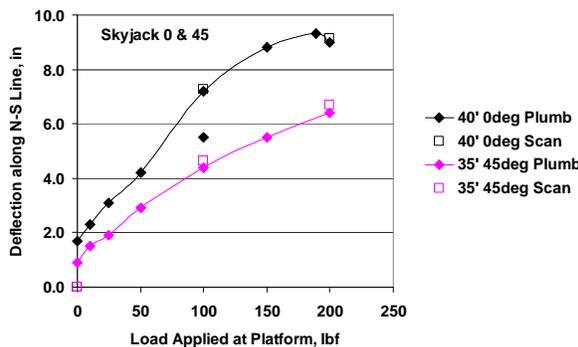
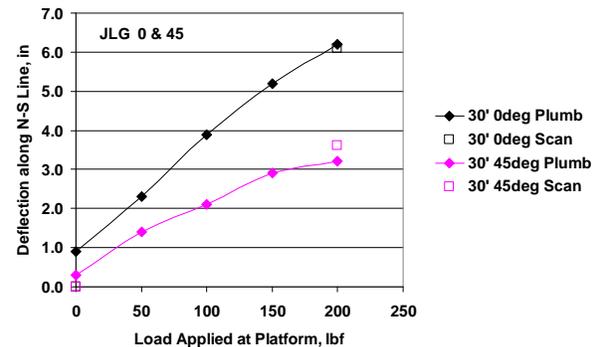
Each lift was tested by applying a series of horizontal forces to the lift’s platform at zero degrees (perpendicular to the long axis of the lift), and at 45 degrees to simulate southwest winds. Results of the deflection tests were measured both with a manual plumb bob hung from the platform and with a laser scanning instrument. The laser scans were then assembled into 3-dimensional computer-based drawings that Peterka could use to measure platform displacement and rotation. When raised to similar heights and placed under similar forces, the Marklift experienced more deflection than the SkyJack and JLG lifts, as depicted by the graphs below.

Peterka then used the deflection data, combined with the wind load analysis he had previously performed, to calculate the lifts' different tipping points. He separated the wind gust speed into North-South and East-West components for application to the scissor lift structures and applied the wind to various elements of the lift, including the platform, lifting section members, and base section, to obtain forces on those individual objects. He then calculated the wind force for each section, and balanced the wind-applied forces against the weight of the lifts. Ultimately, Peterka concluded that the lifts had significantly different tipping points, as illustrated below.

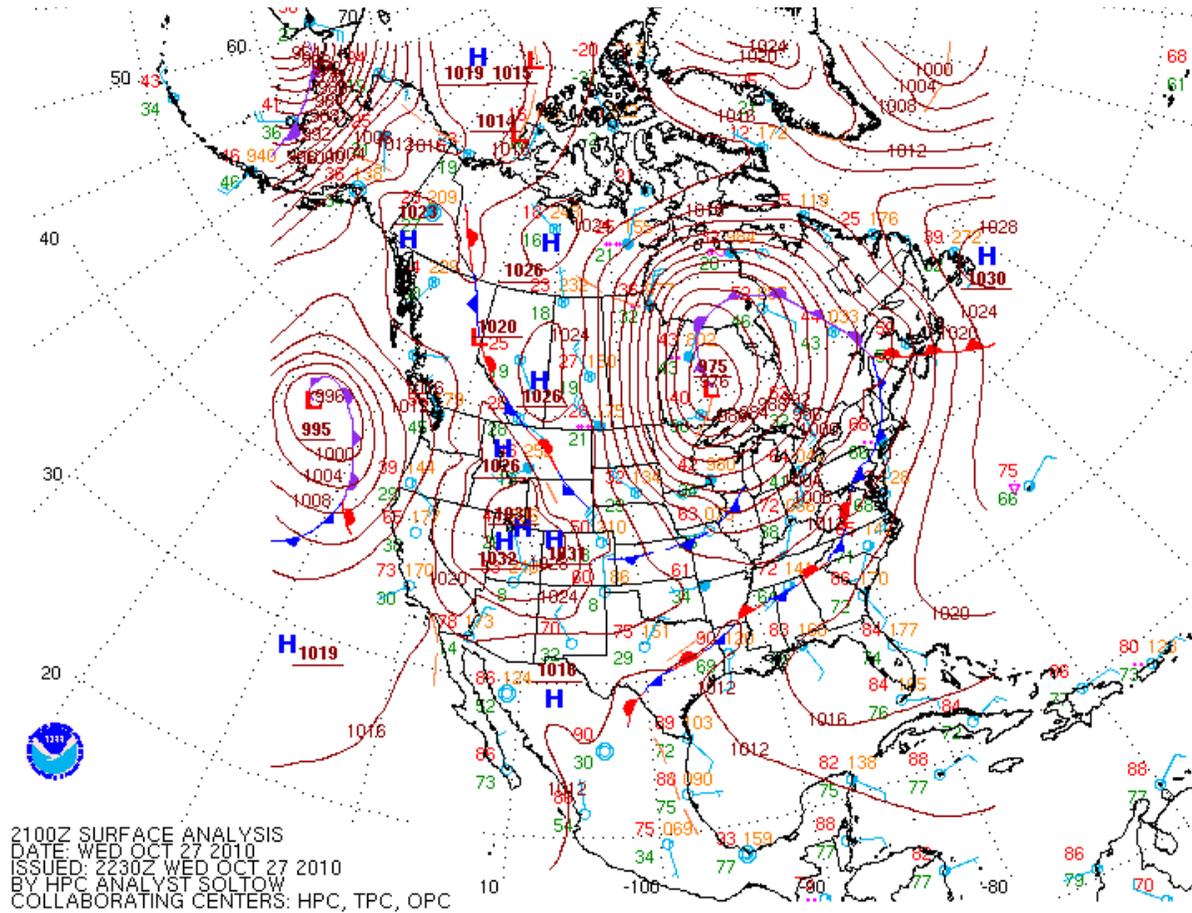
At the time of the accident, about 4:55 pm EDT on 27 October 2010, an intense low pressure system was located in Canada north-northwest of South Bend, IN (see Figure 2). At the center of the low pressure system, a barometric pressure of 975 mb was recorded generating strong winds in the surrounding surface environment (circulating counterclockwise relative to the storm center). While the system was sufficiently distant that South Bend did not experience the low pressure (29.61 inches of Mercury = 1002.7 mb; 1013 mb is the average atmospheric pressure under standard conditions), strong wind speeds did extend from the low pressure area. Wind speeds from the southwest increased in magnitude at the accident site as the low pressure system passed by to the north.

Figure 2. Weather surface analysis map for the time of the accident showing an intense low pressure in Canada north-northwest of South Bend.

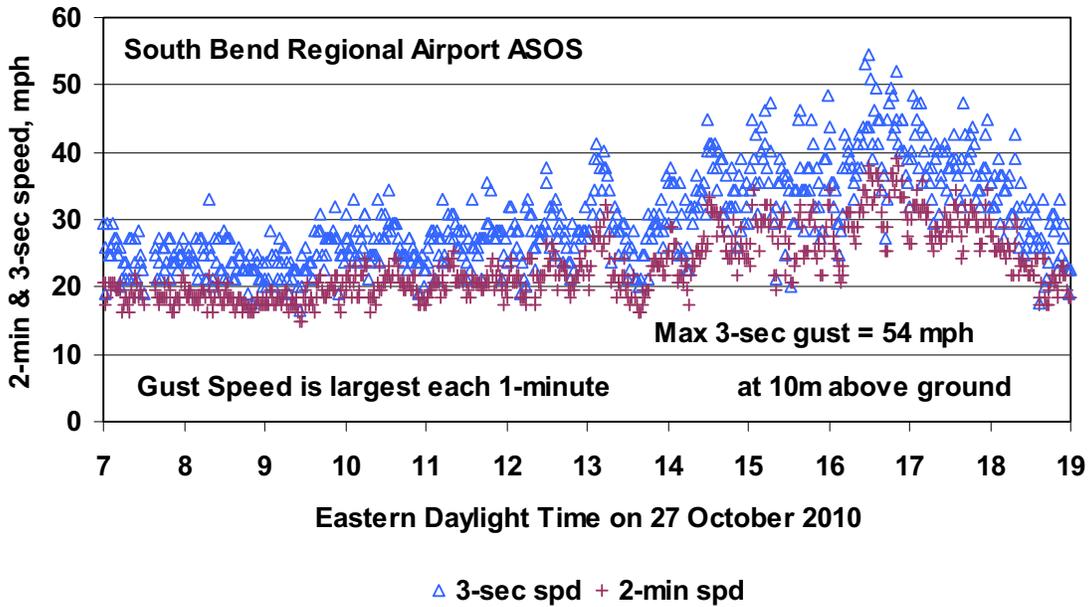
Figure 3 shows wind speeds and directions at the airport for the hours leading up to the accident time of 4:55 pm EDT. In the figure, measured 5-second gusts have been converted to 3-second gusts to be compatible with wind load provisions of ASCE 7, the national wind load standard, since elements of that standard are used in this report to calculate wind loads (for example the largest 5-second speed of 53 mph becomes a 3-second speed of 54 mph). In addition, 30-minute running averages (average over 15 minutes before to 15 minutes after each point in time) of both wind speed and direction have been computed and are presented in Figure 3.

Figure 3a. Two-minute mean wind speeds and 3-second gust speeds from South Bend Regional Airport.

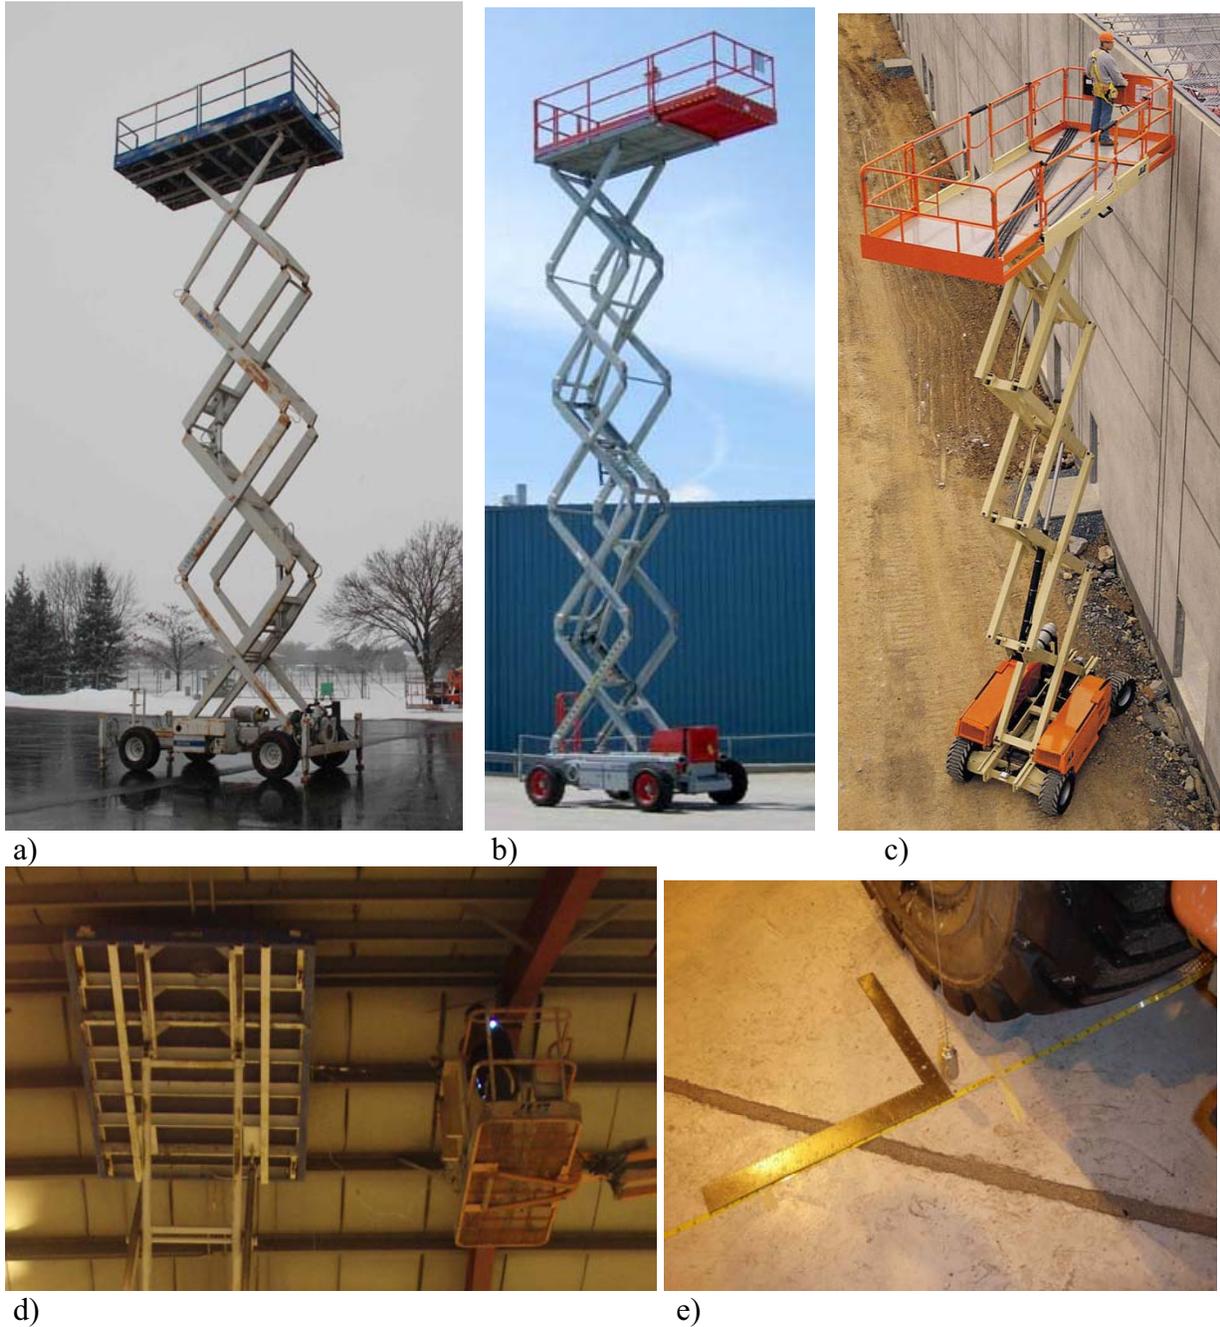
Figure 5. a) Marklift exemplar at 40 ft, b) Skyjack website photo, c) JLG website photo, d) pull cable attached to Marklift at 40 ft, e) plumb bob measurement of deflection.

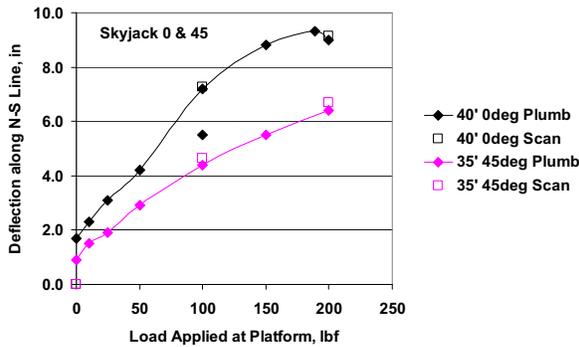
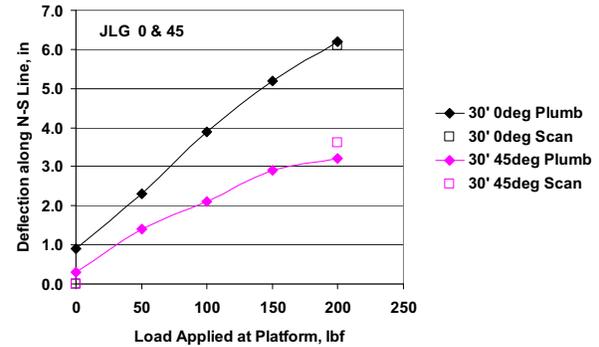
Figure 6. a) to d) Results from the deflection tests;
e) platform angle results compared to a cantilever model.

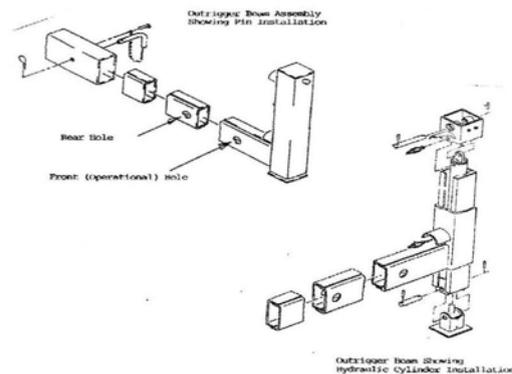
Fig 2 – Outrigger Drawing

The outrigger beam weldment (Figure 2) is designed with two holes in the beam into which the pin may be inserted, one hole close to the vertical jack and one hole at the aft end of the beam. The Marklift operator's manual is silent as to which hole should be used during "on outrigger" operation. However, based on a review of the parts manual drawings (which shows the lift in an elevated position with the outriggers pinned in the hole closest to the vertical jack), an evaluation of the loading and structural properties of the outrigger beam, and my experience with other scissor lifts of this type; it is my opinion that the pin hole closest to the vertical jack is to be used for pinning the outrigger beam during operation.

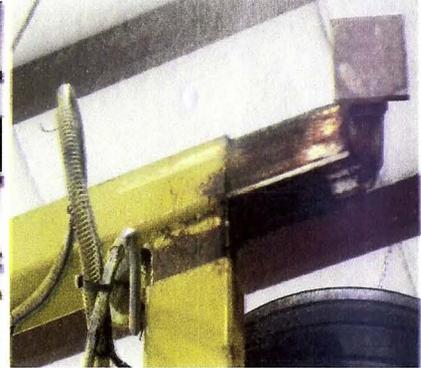
Photo 4 - Left Front Outrigger

Second, four pins normally attached to the outrigger beams were missing and the outrigger sockets were corroded such that the beams were “frozen” 1-5 inches beyond the normal position.

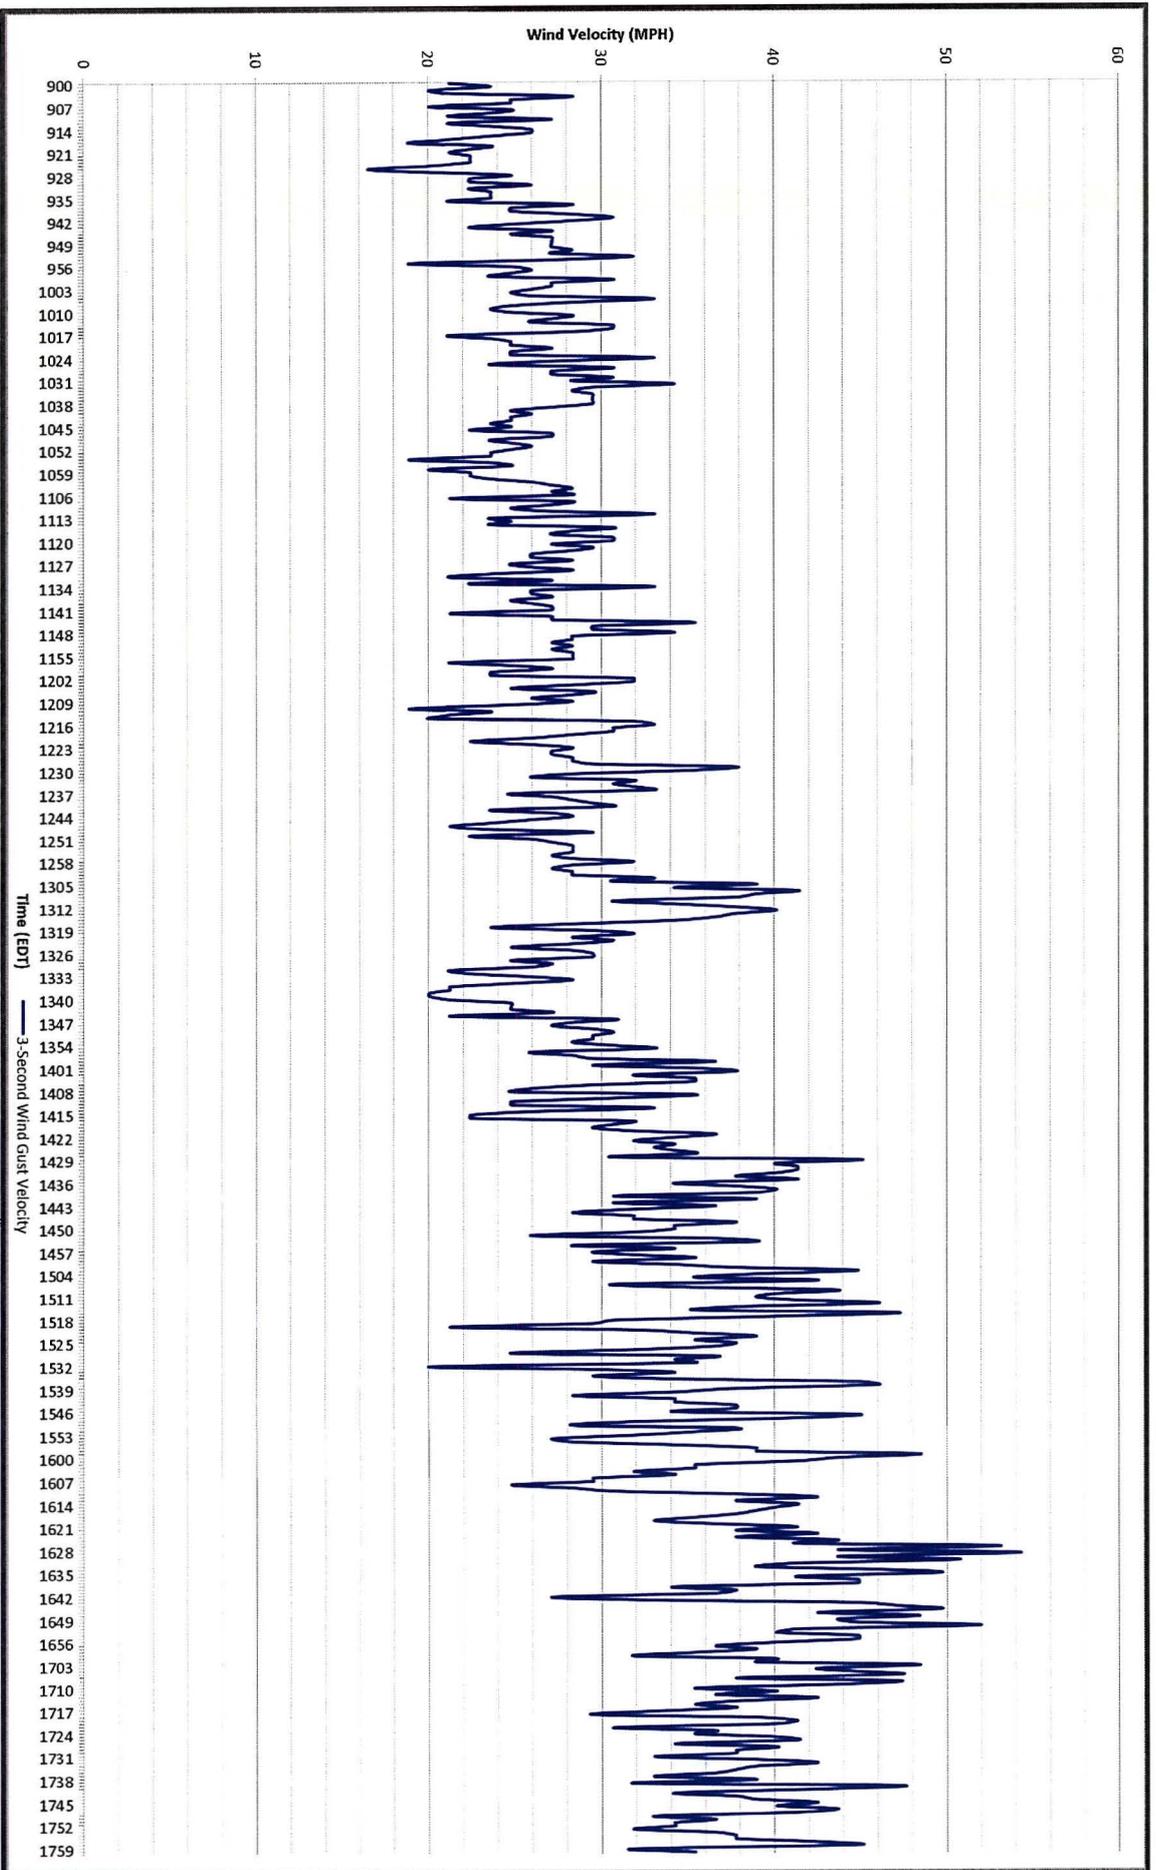
Figure 5 is a graph depicting the 3-second wind gust velocity observed by the KSBN ASOS from 900 AM EDT through 600 PM EDT on October 27th, 2010.

Figure 5: 3-second wind gust velocity observed by the KSBN ASOS from 900 AM EDT through 600 PM EDT October 27th, 2010. Time step 1-minute.
